HN-238
DN-187
EN-80
FN-66

SERVICE BULLETIN

TAIL ROTOR BLADE ABRASION STRIP MODIFICATION

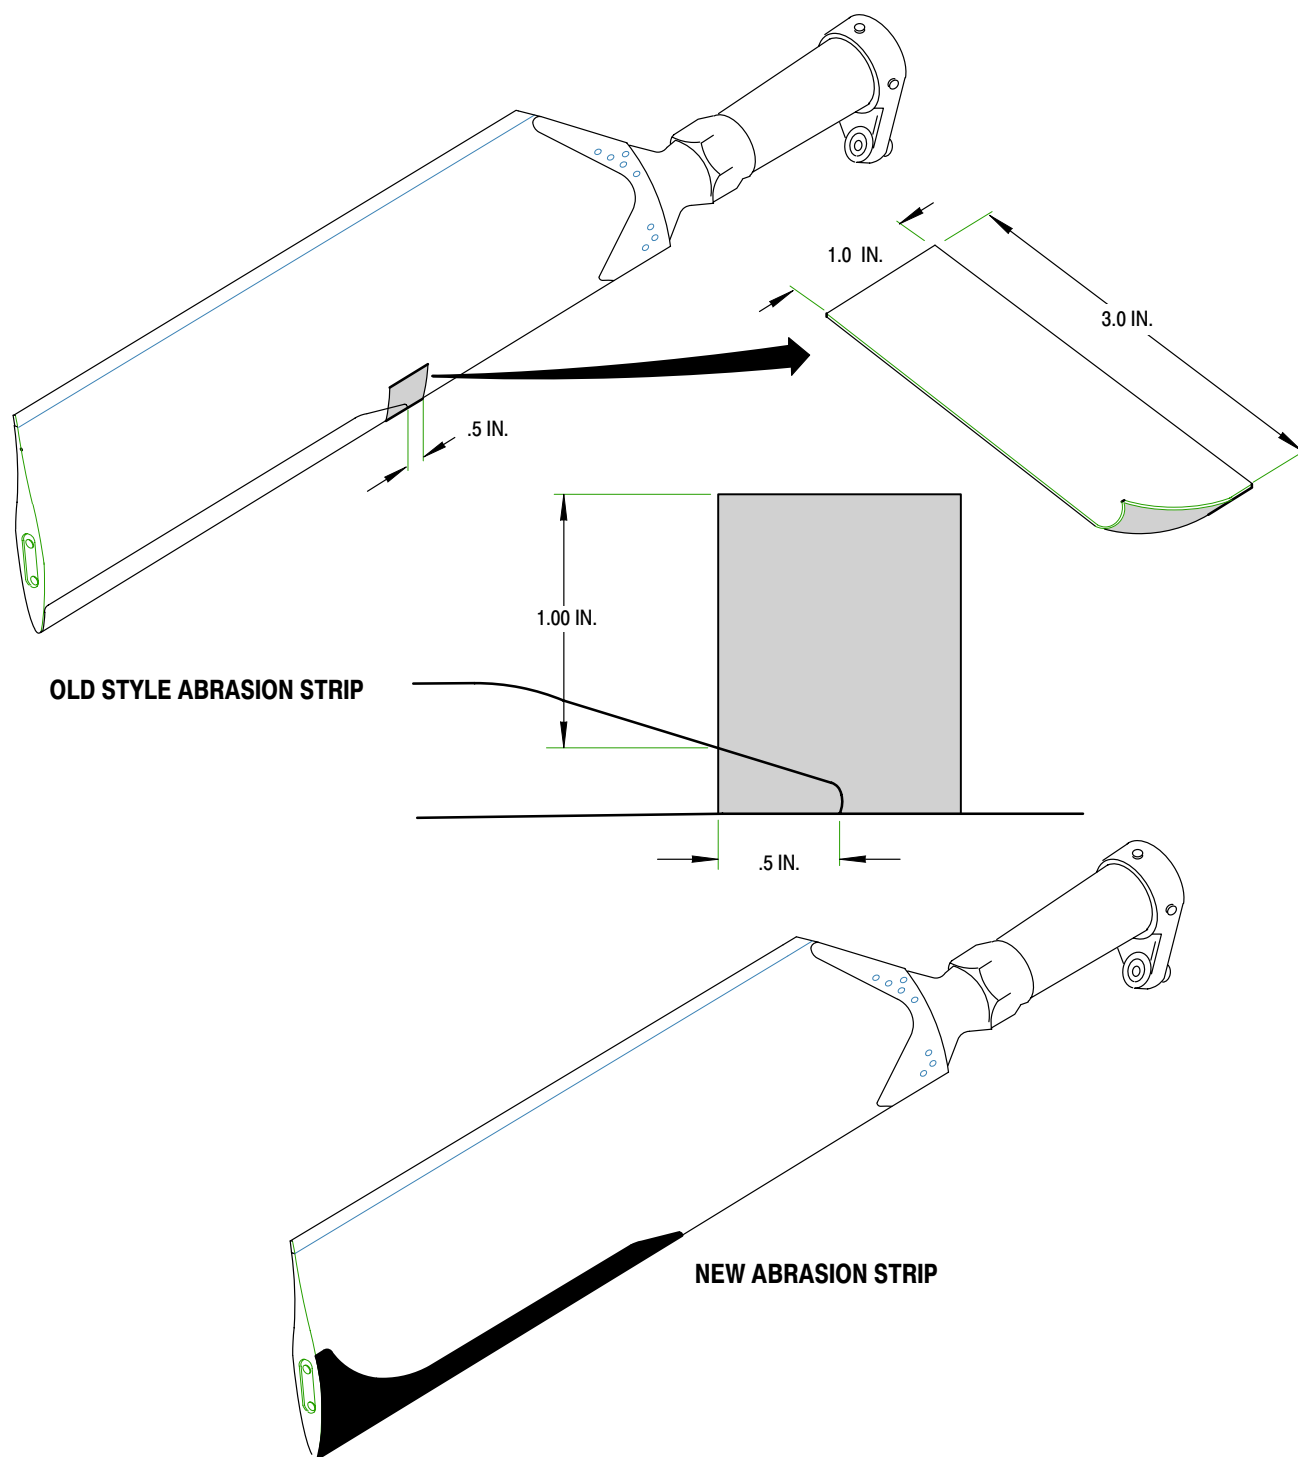
Figure 1. Application of Steel Tape to Tail Rotor Blade.

MDHS has received reports of tail rotor blade abrasion strips debonding during operation. Separation of an abrasion strip could cause loss of the tail rotor gear box due to an out-of-balance condition. Therefore operators are required to comply with the requirements of this notice to ensure safe helicopter operation.

- (2). Lightly abrade faying surface of tail rotor blade in the area where the tape is to be installed with 400 grit abrasive paper (see Figure 1).
- (3). Wipe faying surface of blade with solvent to eliminate grease and dirt film.

- (4). Use heat gun or equivalent to warm blade faying surface. Temperature must not exceed 120 deg. F.
- (5). Remove backing and apply stainless steel abrasion tape to leading edge of tail rotor blade as shown in Figure 1. Apply tape so it overlaps each side of blade equally. Tape should overlap the inboard end of abrasion strip .5 in. +/- .03 at the leading edge of the blade.

1. 304 STAINLESS STEEL TAPE SHALL BE APPLIED; 1/2-INCH TO ABRASION STRIP AND 1/2-INCH TO TAIL ROTOR BLADE.
2. APPLY TAPE EQUALLY TO BOTH SIDES OF BLADE.
