SERVICE BULLETIN

DATE: 23 JANUARY 2006

TAIL ROTOR BLADE ABRASION STRIP TAP TEST AND MODIFICATION

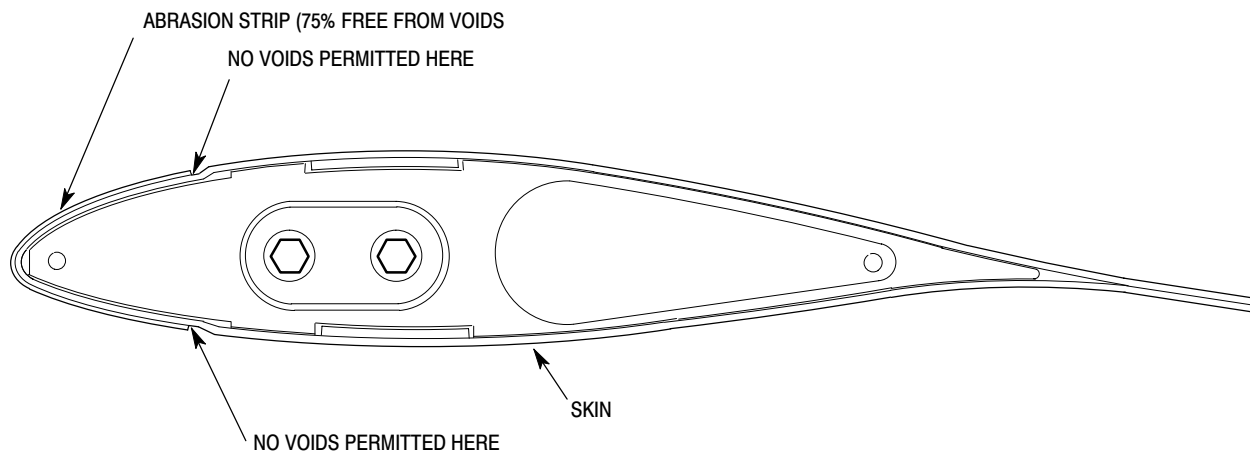
Figure 1. Tail Rotor Blade Abrasion Strip Inspection

- (1). Perform a tap test on both upper and lower surfaces of abrasion strip surfaces on each tail rotor blade as follows:
 - (a). The tap test may be conducted using a coin (U.S. 25 cent piece or equivalent) or a small brass, mild steel or aluminum hammer.
 - (b). Lightly tap abrasion strip area as shown (Ref. Figure 1). Tap in a pattern with no more than 0.13 inch (3.30 mm) between taps in any direction.

- (c). Inspect (tap test) abrasion strip to skin bond from inboard end of blade to blade tip in spanwise direction and from leading edge to aft edge of abrasion strip in chord-wise direction.
- (d). Allowable void size in abrasion strip area is 0.2 square inch (5.08 square mm). There shall be 1.0 inch (25.4 mm) between voids in this area.
- (e). Seventy-five percent of the abrasion strip bonded area shall be free from voids, except that no voids shall break out to the edges of the abrasion strip. The upper and lower surfaces shall be considered separately.

- (2). Remove from service any tail rotor blade that does not meet the above inspection requirements.
