# SERVICE BULLETIN

## TAIL ROTOR BLADE ASSEMBLY, ONE TIME INSPECTION

## Service Bulletin SB369H-247, SB369D-204, SB369E-099, SB369F-084, One Time Inspection of the Tail Rotor Blade Assemblies

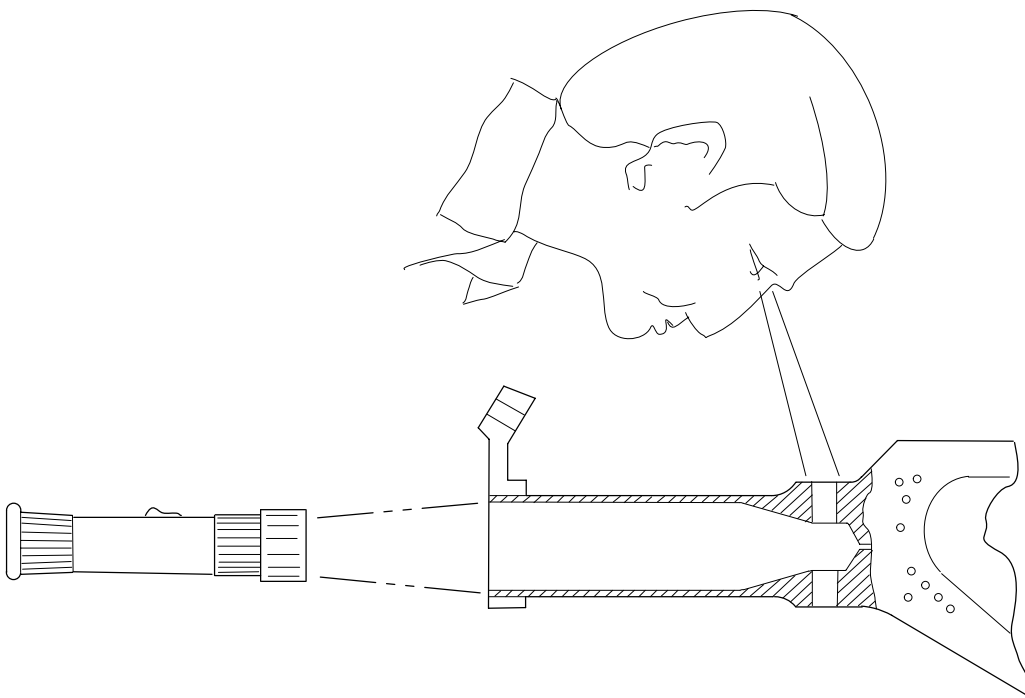
**Figure 1. Method for Visual Inspection of the Root Fitting**

- (4). Use a bright light to inspect the bore of the tail rotor blade root fitting (Ref. Figure 1). Make sure the transition from the bore to the tapered end has a smooth radius (Ref. Figure 2).
- (5). A tail rotor blade assembly that is not acceptable will have a sharp transition (Ref. Figure 2)
- (6). Replace all blade assemblies that are missing a smooth radius (Ref. Figure 2).

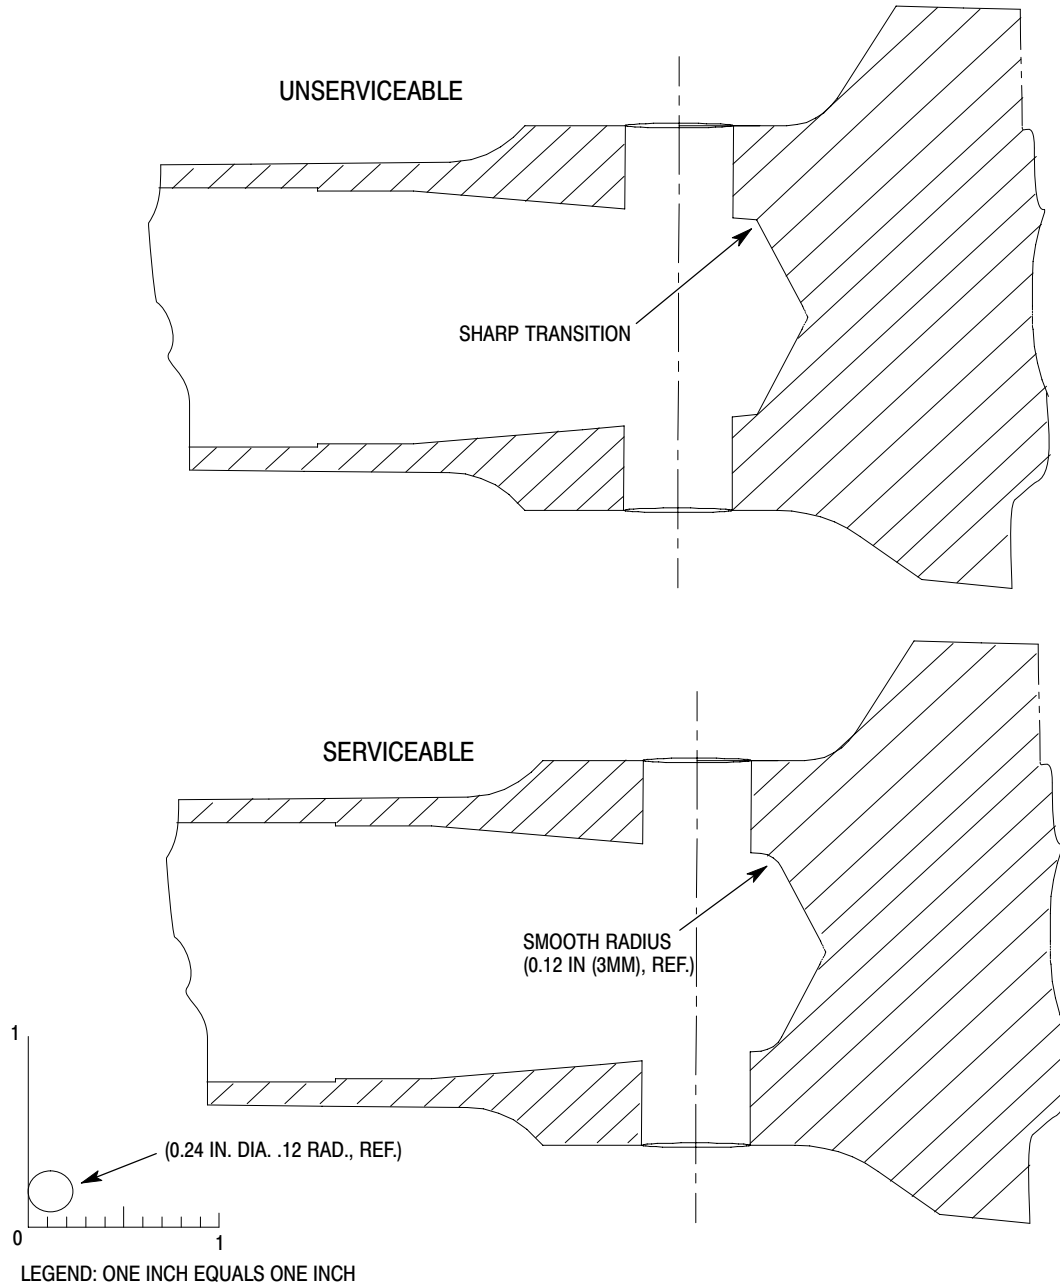
**Figure 2. Cross Section of Blade Root Fitting**

Reports from the field have shown that there are tail rotor blades in operation with a machining defect. These blades have a sharp transition in the tapered end of the root fitting bore that can cause the tail rotor blade root fitting to fail. A crack in the tail rotor blade root fitting can result in the loss of the tail rotor and loss of directional control of the aircraft.
