SERVICE BULLETIN

DATE: 28 NOVEMBER 1986 PAGE 1 OF 7

SUBJECT: INSTALLATION OF FAILSAFE DEVICE AT TAIL ROTOR DRIVE SHAFT AFT FLEXIBLE COUPLING, P/N 369A5501 or 369H2564: AND INSPECTION OF FLEXIBLE COUPLINGS.

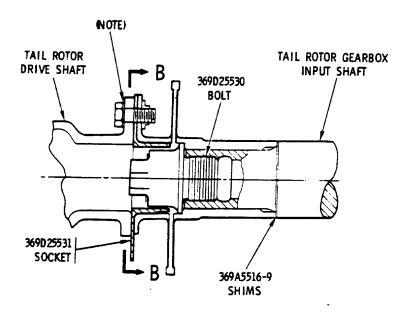
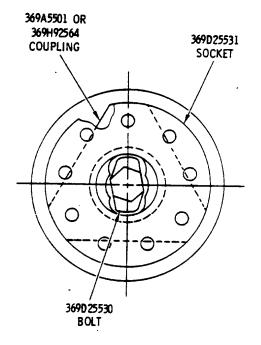
Figure 1. Installation of Failsafe Device, Aft Tail Rotor Coupling

PREFACE: Part I of this Notice provides instructions for installing a failsafe device to provide an additional drive connection between the tail rotor drive shaft and the tail rotor transmission at the aft flexible coupling. The failsafe device consists primarily of a new 369D25530 coupling bolt to secure the aft flexible coupling to the tail rotor drive shaft and a new 369D25531 socket installed between the connecting flanges of the aft coupling and the tail rotor transmission. The new coupling bolt incorporates a key which engages a corresponding keyway in the locket, thus providing an alternate drive link if coupling failure should occur.

F. Install aft socket (P/N 369D25531) between tail rotor gearbox and tail rotor drive shaft as shown in Figure 1. Torque aft coupling tail rotor bolts to 80 to 100 inch pounds.

With tail rotor drive shaft removed, inspect flexible couplings per Section 9 HMI Vol. I. Also visually inspect forward and aft coupling bolts and sockets for indications of contact. Do not loosen or remove bolt. If signs of contact are noted, remove and reinstall socket and/or coupling bolt so that maximum clearance is obtained between bolt key and socket. (See View B-B, Figure 1.) Visually verify proper clearance before reinstalling tail rotor drive shaft.

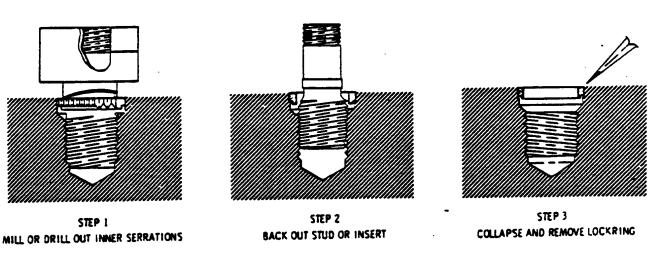
Figure 2. Stud and Insert - Typical Replacement

K. Verify that a minimum of (1) one thread protrudes from each of the four tail rotor gearbox mounting studs. If less than one thread is showing, replace mounting studs per the following steps:

2) Using Rosan wrench (P/N R1105W) and removal tool (P/N SM101-18) remove existing studs as shown in Figure 2.

- 3) Install MS51992A803 -14 studs.
- 4) Repeat Step J.
