SERVICE BULLETIN

DATE: 03 MAY 1999

TAIL ROTOR BLADE, LEADING EDGE INSPECTION FOR CRACKS

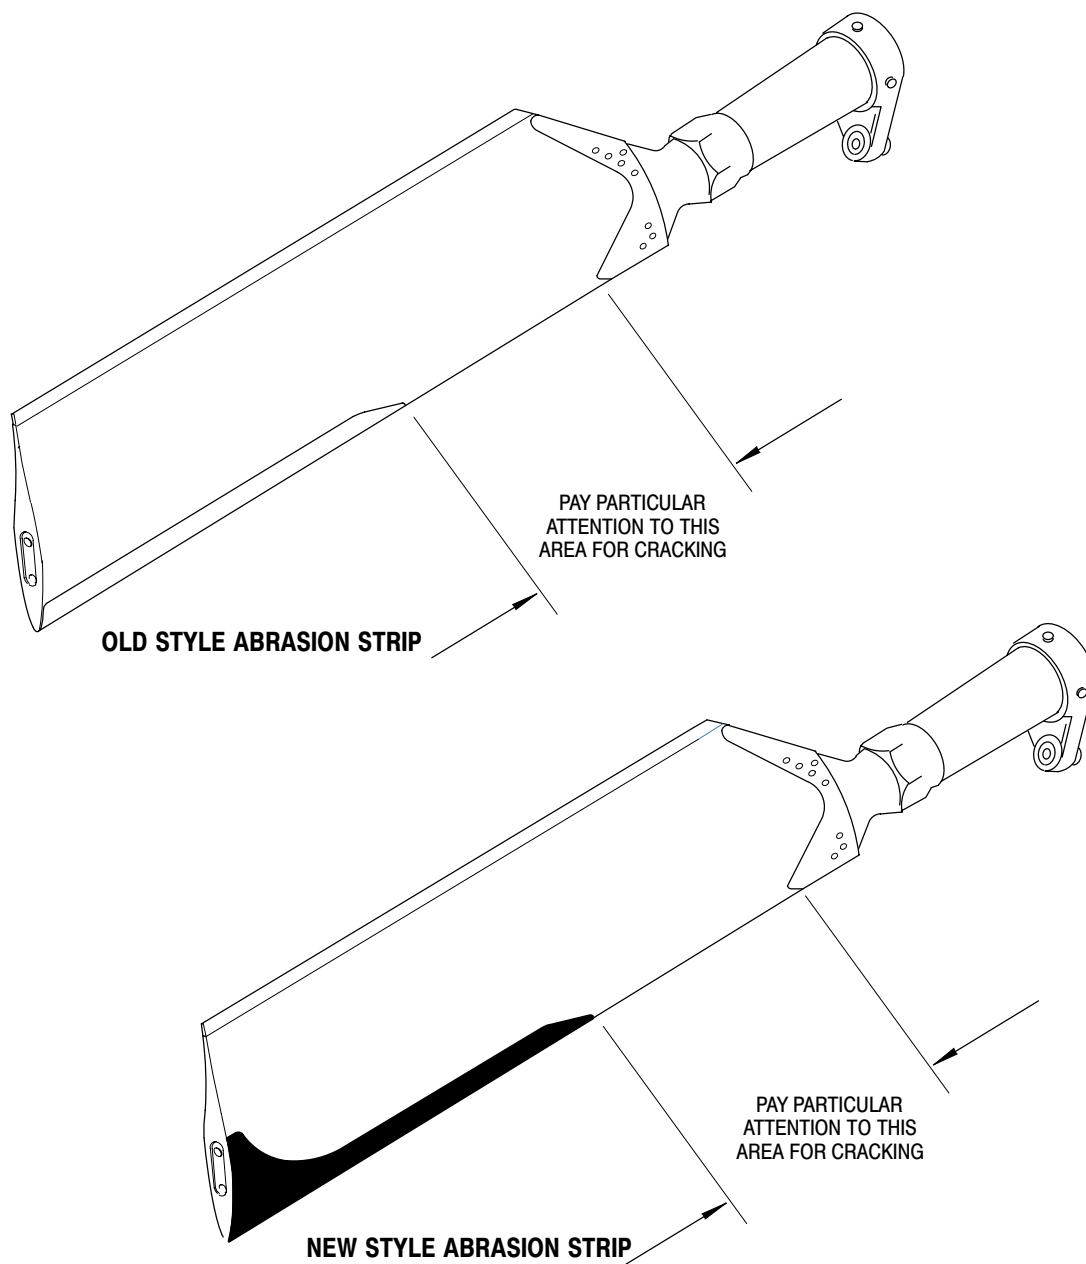
Figure 1. Tail Rotor Blade Inspection

Boeing has received a tail rotor blade from an operator that shows evidence of blade skin cracking at the inboard end of the abrasion strip. No cracks are allowed at this or any other location on tail rotor blades. Failure to comply with the requirements of this Bulletin may result in tail rotor blades failing in service and subsequent loss of directional control of the helicopter.

- (a). Inspect leading edge for any evidence of cracking in the area shown in Figure 1. No cracks are allowed. If cracks are suspected, perform a dye penetrant inspection of the suspect area as follows:
- 1). By lightly abrading the blade skin, carefully remove the paint from the suspect area.

- 2). Perform dye penetrant inspection on the suspected area per MIL-I-25135 (or equivalent).
 - 3). Tail rotor blades with evidence of cracking must be removed from service.
NOTE: Tail rotor blades with the new abrasion strip configuration cannot be intermixed with tail rotor blades that have the old abrasion strip configuration.

- 4). If there is no evidence of cracking, the blade can be cleaned and touch-up epoxy paint applied to the affected area.
- (b). To reduce erosion, up to a 2 inch length of 3M transparent protective tape may be applied to all blades. An equal length of tape must be applied to all blades. The protective tape should be applied spanwise centered on the leading edge and overlap the inboard end of the abrasion strip by approximately 1/2 inch. The square corners of the tape should be rounded off before application to reduce the chance of peeling. 3M Promoter 86 may be used to improve adhesion of the tape.

- (c). The tape should be inspected for condition and security during the preflight inspection. Evidence of erosion, lifting or movement requires tape replacement.
- (2). Inspect tail rotor blades with old style abrasion strips as follows:
- (a). Remove stainless steel tape from the leading edge at the inboard end of the abrasion strip.
 - (b). Inspect that area for evidence of cracks. No cracks are allowed. If cracks are suspected, perform a dye penetrant inspection of the suspect area as follows:
 - 1). Carefully remove the paint from the suspect area.

- (c). Install new stainless steel tape in the same location as follows or perform PART II of HN-238, DN-187, EN-80 and FN-66:
 - 1). Lightly abrade faying surface of tail rotor blade in the area where the tape is to be installed with 400 grit abrasive paper.

- 4). Remove backing and apply stainless steel abrasion tape to leading edge of tail rotor blade. Apply 3.0 in. x 1.0 in. tape so that it overlaps each side of blade equally. Tape should overlap the inboard end of the abrasion strip 0.5 inch +/- 0.03 in. at the leading edge of the blade.
