**HUGHES
SERVICE INFORMATION
NOTICE**

NOTICE NO. HN-68

SUBJECT: TERMINAL INSPECTION/MODIFICATION - NI-CAD
BATTERY PN 369A4530 AND 369H4540

MODELS AFFECTED: All 369H Series Helicopters having subject battery and
batteries furnished as shares replacement, delivered
from 1 June 1973 through 1 February 1974.

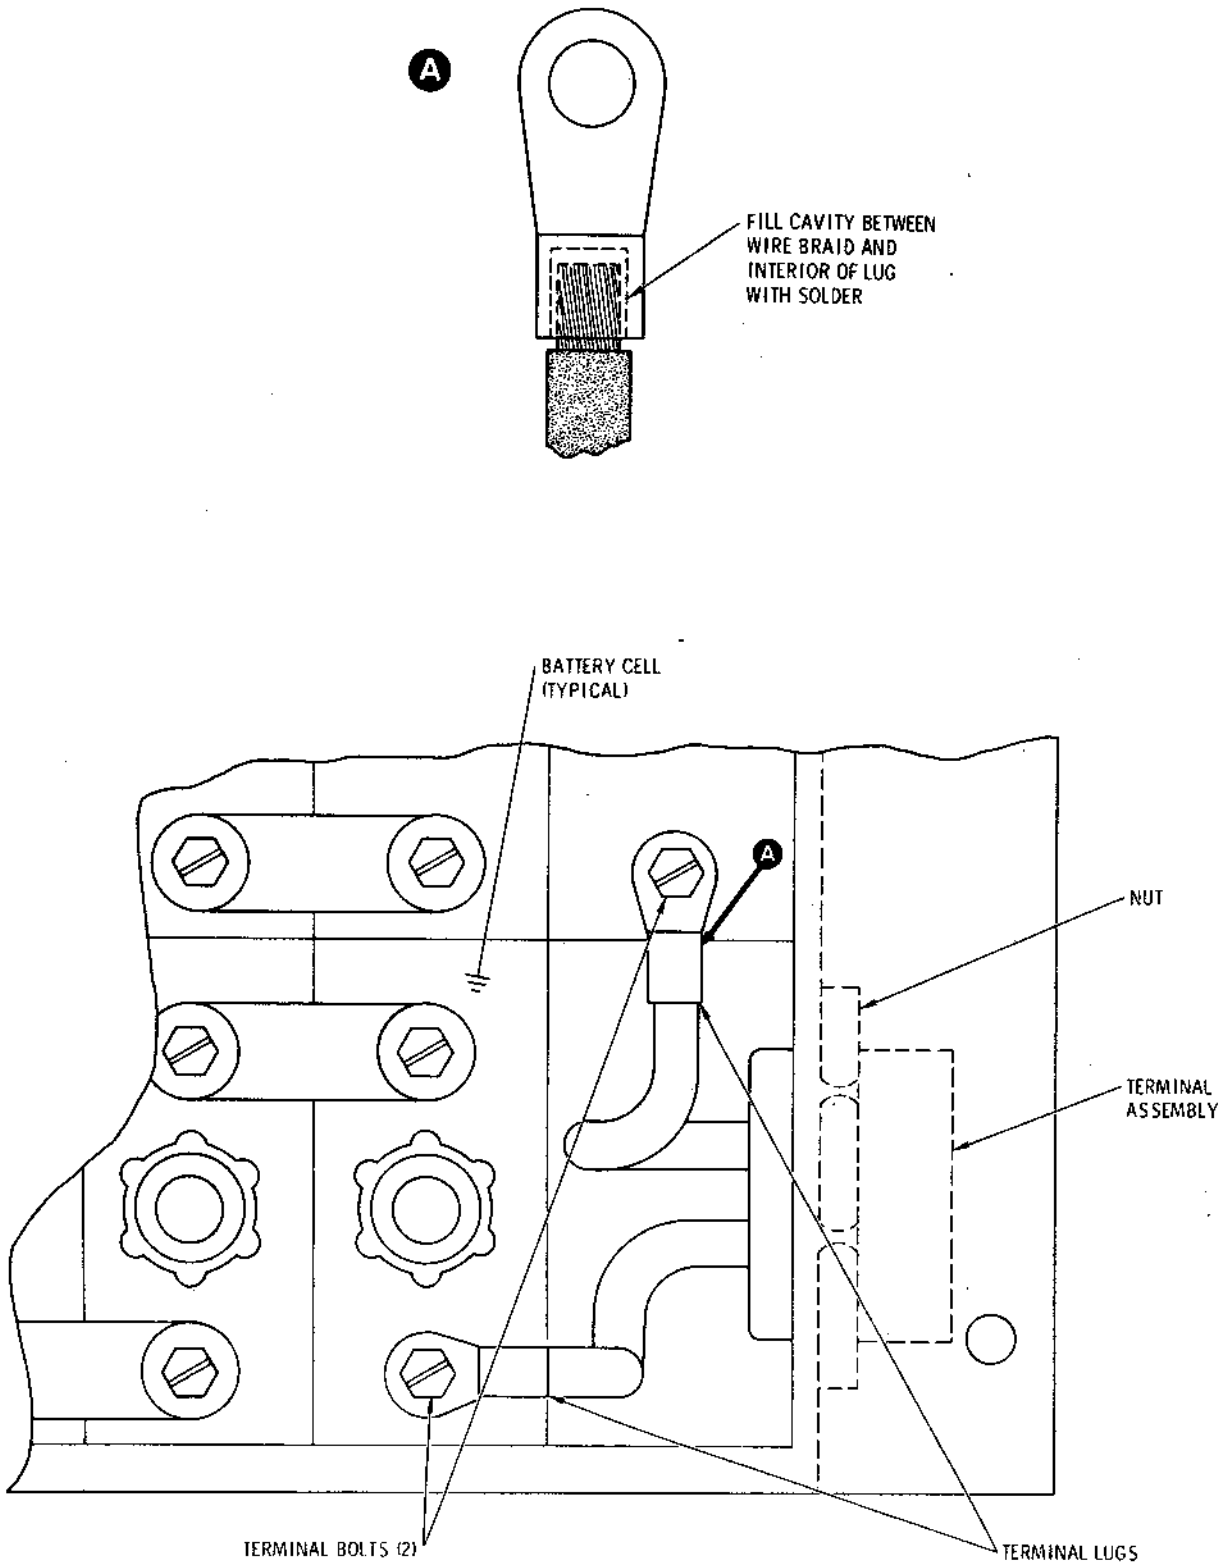
PREFACE: Instances of looseness between the battery terminal and cable have been
observed. This condition can promote corrosion, erratic current flow, and
under certain conditions a run-away battery.

Figure 1. Battery terminal inspection - modification

- f. Inspect lug and wire for solid joint.
- g. Install terminal assembly on battery in reverse order of removal.
- h. Identify battery by stenciling "T - S" on battery.
- i. Torque terminal bolts to 15-18 inch-pounds.
- j. Record compliance with this Service Notice in Compliance section of Helicopter Log Book.
