SERVICE BULLETIN

DATE: 16 APRIL 2013
 PAGE 3 OF 10

SB369H-253R1 SB369D-211R1
 SB369E-106R1 SB369F-092R1
 SB500N-048R1 SB600N-056R1

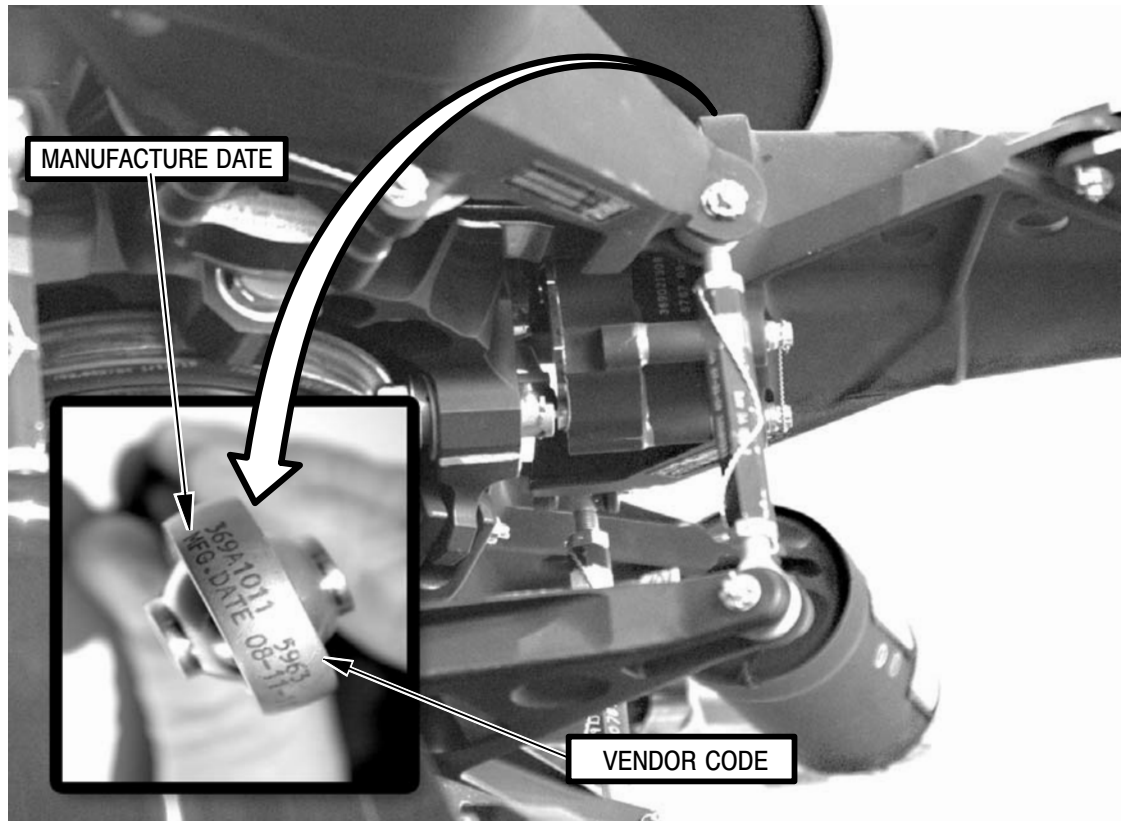
Figure 1. Installed Main Rotor Pitch Control Rod Assembly

- (b). Examine each installed upper main rotor pitch control rod end for vendor code 5963 and a manufacture date between 07-01-11 and 08-31-11. (Ref. Figure 1).

- (2). Do a spares inventory inspection of the main rotor pitch control rod ends purchased between July 2011 and November 2012 as follows:
 - (a). Examine each main rotor pitch control rod end for vendor code 5963 and a manufacture date between 07-01-11 and 08-31-11. (Ref. Figure 1).

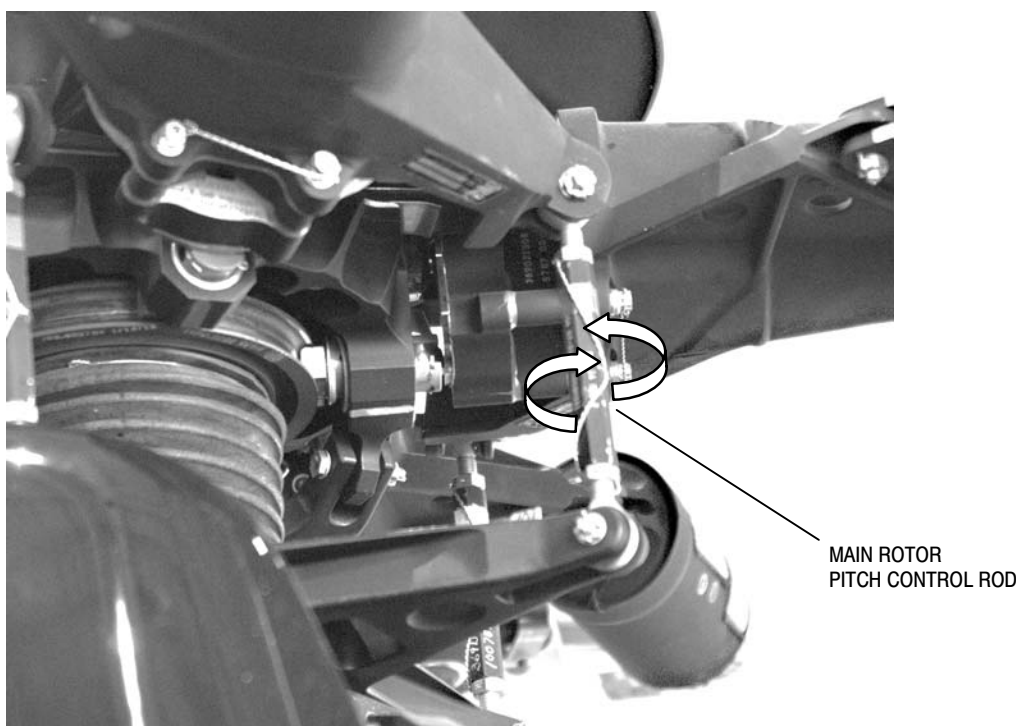
Figure 2. Main Rotor Pitch Control Rod Assembly Movement Check

- (1). Turn the main rotor pitch control rod assembly with a back and forth movement. (Ref. Figure 2).
- (2). If the main rotor pitch control rod assembly does not turn back and forth freely, do Step 2.C. before the next flight.

- (1). One at a time, turn each main rotor pitch control rod assembly in a back and forth movement. (Ref. Figure 2).

- (2). If all main rotor pitch control rod assemblies turns back and forth freely, the main rotor pitch control rod assembly rod ends are serviceable and flight operations can resume for the day.
- (3). If any one of the main rotor pitch control rod assemblies does not turn back and forth freely, the main rotor pitch control rod end is not serviceable. Do Step 2.C. before the next flight.

- (3). If the main rotor pitch control rod assembly turns back and forth freely, do one of the following steps:
 - (a). Do Step 2.C. for immediate replacement, or.
 - (b). Do Step 2.E. for replacement of the main rotor pitch control rod end at a later date. Replacement can be postponed for a period of up to, but no later than, 300 flight hours or one year, whichever occurs first.
- (4). Do Step 2.B.(1)., Step 2.B.(2)., and Step 2.B.(3). again for each main rotor pitch control rod assembly.
