SERVICE BULLETIN

DATE: 30 SEPTEMBER 1980
PAGE 1 OF 3

WIRING MODIFICATION – UTILITY LIGHT CIRCUIT AND TRANSMISSION OIL PRESSURE AND TEMPERATURE WARNING LIGHT CIRCUIT

All 500 Model 369H, 369HE and 369HS Helicopters

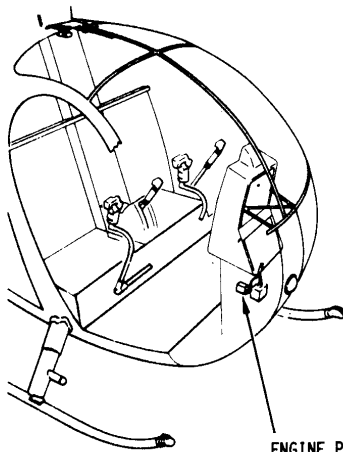
Figure 1. Wiring Modification - Utility Light And Transmission Warning Light

The information given in this Service Information Notice lists a procedure for rewiring the utility light circuit and the transmission oil pressure temperature warning light circuit on Model 369H, 369HE and 369HS helicopters. The purpose of the wiring modification is to eliminate deactivation of the utility light and transmission warning light circuits in the event the engine power out (EPO) unit is deactivated by tripping the EPO circuit-breaker.

- a. Check that all electrical power is OFF.
- b. Remove instrument panel hood and side fairings. (Refer to Section 17 of Basic. HMI.)
- c. Remove circuit breaker panel from instrument console. (See Figure 1.)

- d. Disconnect electrical wiring harness connector from EPO warning unit plug (P19). (Refer to Section 19, Basic HMI.)
- e. Disconnect existing transmission warning light circuit wire No. E518A22 from pin K of P19 wiring harness connector plus (or from pin K of P3 plug if VAPAIR EPO unit is installed).

- f. Connect wire No. E518A22 to PNL LT circuit breaker CB104-2, using terminal lug MS25036-149.
- g. Remove existing UTIL LT circuit wire No. L531A22 (or MAP LT circuit wire No. E531A22 on early helicopters) from ENG OUT circuit breaker CB106-2 on panel; connect wire No. L531A22 (or E531A22) to N2 GOV circuit breaker CB103-2 on panel.

L531A22 (NOTE 2)	CB103-2	MS25036-149
E518A22	CB104-2	MS25036-149
