**CESSNA AIRCRAFT COMPANY
MODEL 300 SERIES
CONTINUED AIRWORTHINESS PROGRAM**

TITLE **Wing Fuselage Attach Fittings Inspection**

MODEL	EFFECTIVITY	INSPECTION COMPLIANCE
336	336-0001 Thru 336-0195	INITIAL 12,000 HRS REPEAT 3000 HRS Thereafter
337 Thru T337H-SP	337-0002 Thru 33701955	
T337G Thru P337H	337-0002 Thru 33701955	
F337E/FT337E	F3370001 Thru F33700055	
FT337GP/FT337HP	FP33700001 Thru FP33700023

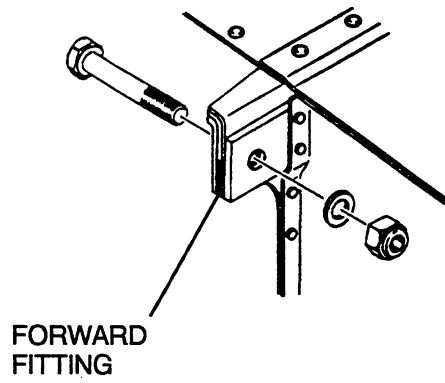
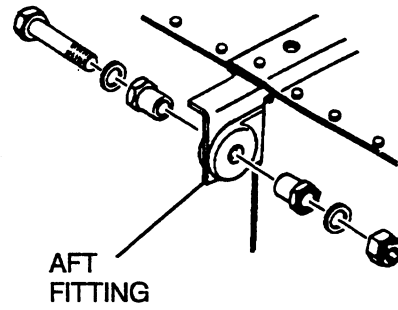
Wing Fuselage Attach Fitting
Figure 3-22

To eddy current inspect primary load path of forward and aft spar fitting.
There is one known history of cracking, except for rear spar web referred to in CAP Item 57-10-03.

1. Inspect for possible cracking from wing attachment holes outward. (Refer to step 4.)
2. Possible galling or deformation of wing attachment holes. (Refer to step 4.)
3. Check wing attach bolts for looseness, If bolts are loose, remove wing attach bolts and inspect for cracks. (Refer to step 4.)
4. Eddy Current Inspect, per instructions in Section 4-0, "Basic Information."

No Cracks Allowed

Replace cracked parts.

Ref: ME74-4
Contact Cessna Aircraft Company for instructions if oversize holes are found.
