**CESSNA AIRCRAFT COMPANY
MODEL 300 SERIES
CONTINUED AIRWORTHINESS PROGRAM**

TITLE **Wing Rear Spar Web**

337 Thru T337H-SP
T337G Thru P337H
F337E/FT337E
FT337GP/FT337HP

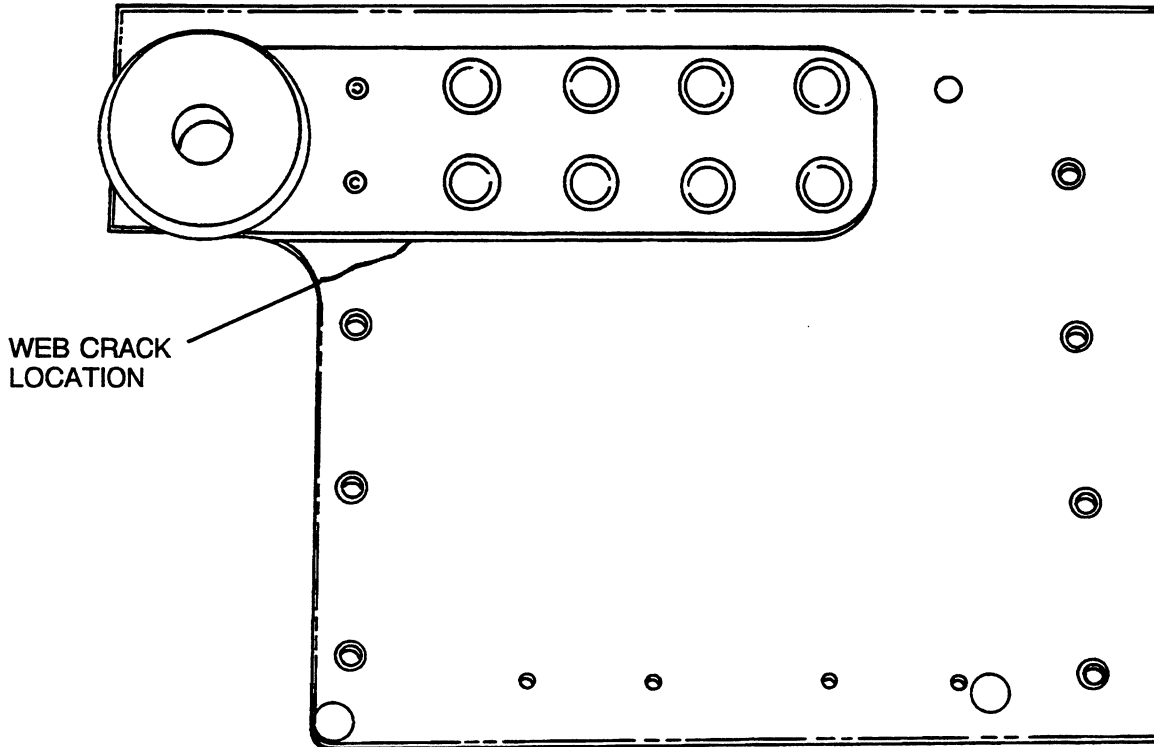
Rear Wing Spar Web - Inboard
Figure 3-23

1. Inspect web under wing rear spar fuselage attach fitting, paying particular attention to web inboard edge.

Remove wing-to-fuselage fairing strip.
Lower flaps and remove access cover.
Location: Web - Wing rear spar fuselage attach fitting area.

Report any evidence of cracking to Cessna Aircraft Company.
