SB369H-245R2\* SB369D-201R2\* SB369E-095R2\* SB369F-079R2\* SB500N-023R2\* SB600N-031R2\*

SERVICE BULLETIN

MANDATORY

## MAIN ROTOR BLADE ASSEMBLY TORQUE EVENT INSPECTION

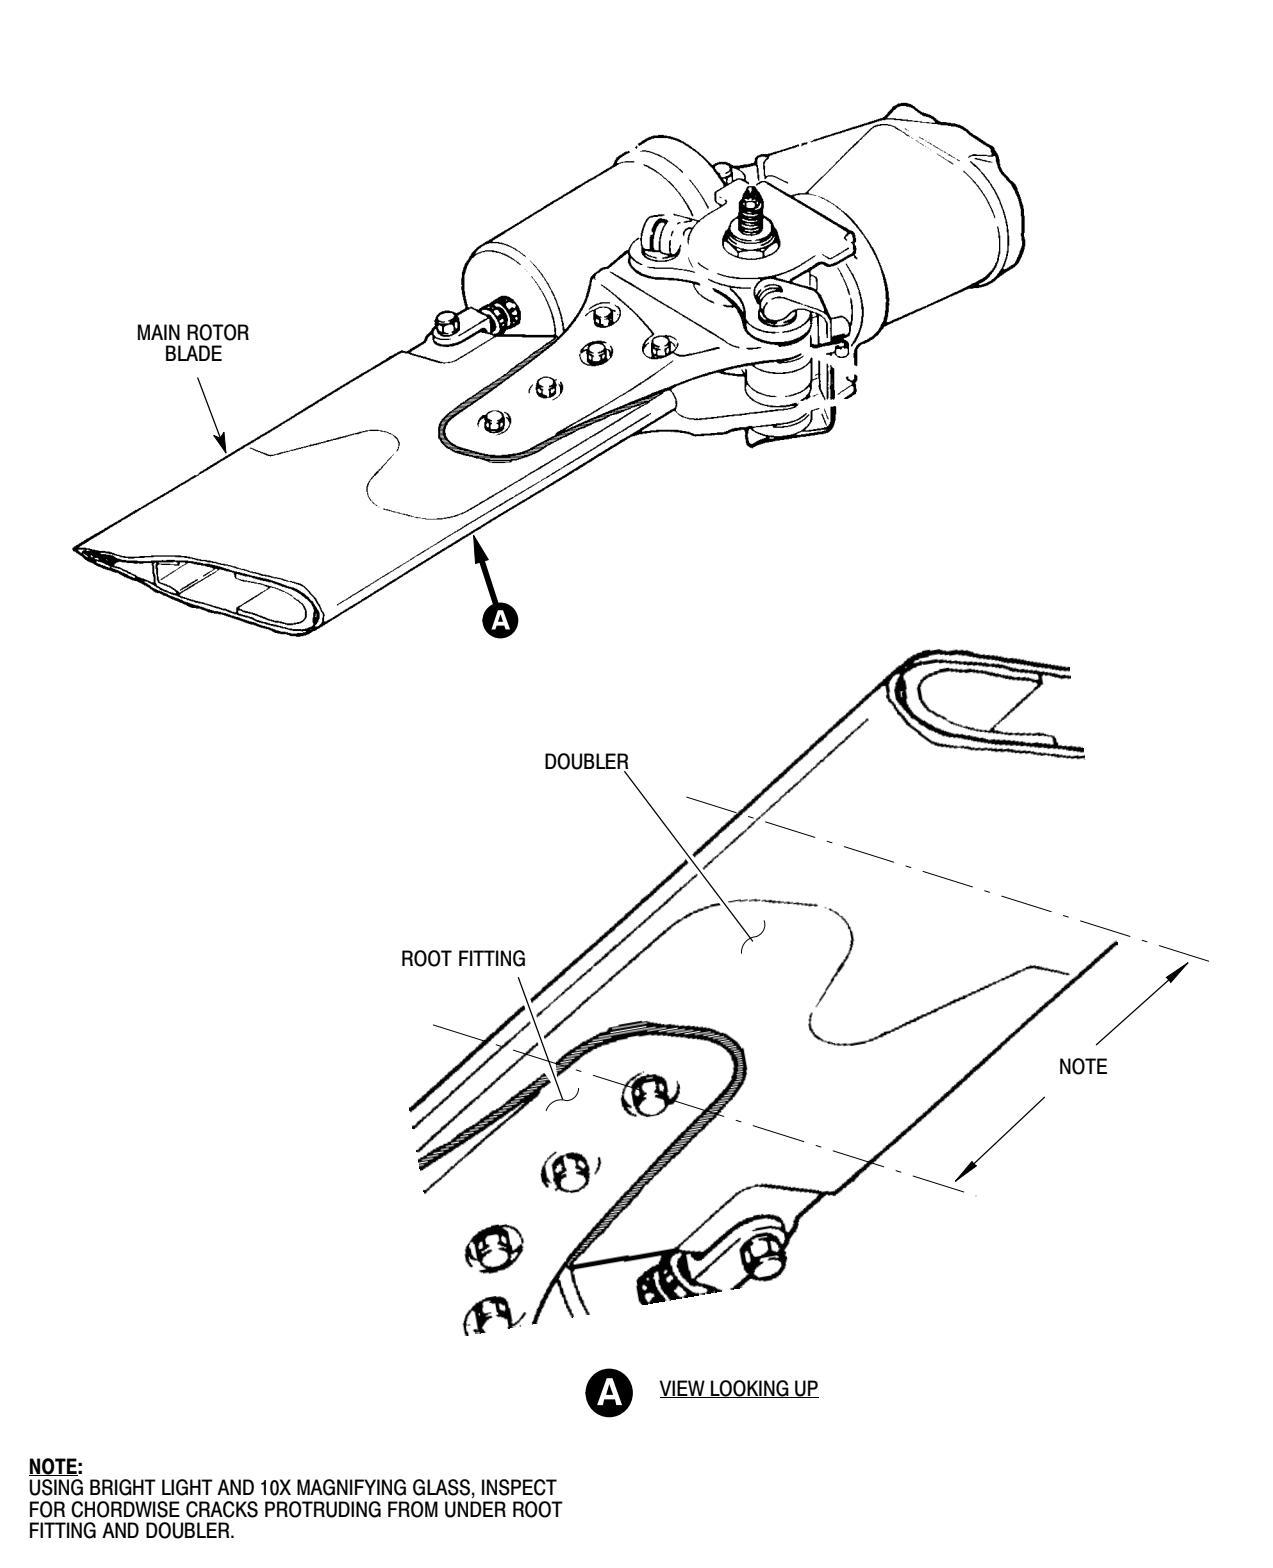
#### Figure 1. Main Rotor Blade Torque Event Inspection

Some operators have experienced cracking of main rotor blades. These cracked blades have been associated with a high number of torque events/external lifts per hour which exceed the original design fatigue spectrum. This bulletin references criteria to assist operators in understanding their level of usage, the impact of that usage on the main rotor blade life and the corresponding inspections required to locate cracks that might occur. Failure to comply with this bulletin may result in the loss of a main rotor blade.

(3). When inspecting bottom side of blade, using bright light and 10x magnifying glass, inspect for chordwise cracks protruding from under root fitting and doubler.

- (1). Determine the main rotor blade TE inspection interval, using current number of TE (Ref. CSP-HMI-2, Section 04-00-00, Table 1. Airworthiness Limitations Component Mandatory Replacement Schedule).
- (2). Inspect main rotor blades at the required interval (Ref. CSP-HMI-2, Section 62-10-00, Main Rotor Blade Torque Event Inspection), to include the following.

- A record of TEs must be kept (Ref. CSP-HMI-2, Section 04-00-00, Table 1, Airworthiness Limitations Component Mandatory Replacement Schedule).
- It is recommended to paint the inboard 24 inches (not to be exceeded) of the blade gloss white to aid in crack detectability. If this is done, all blades must be painted alike and re-balanced. (Ref. CSP-HMI-2, Section 20-30-00, Main Rotor Blade Painting.)
