SERVICE BULLETIN

HN-199.1* DN-132.1* EN-21.1* FN-9.1* DATE: 01 MAY 1985 PAGE 1 OF 5

RIVETING TIP-CAP TO TAIL ROTOR BLADE

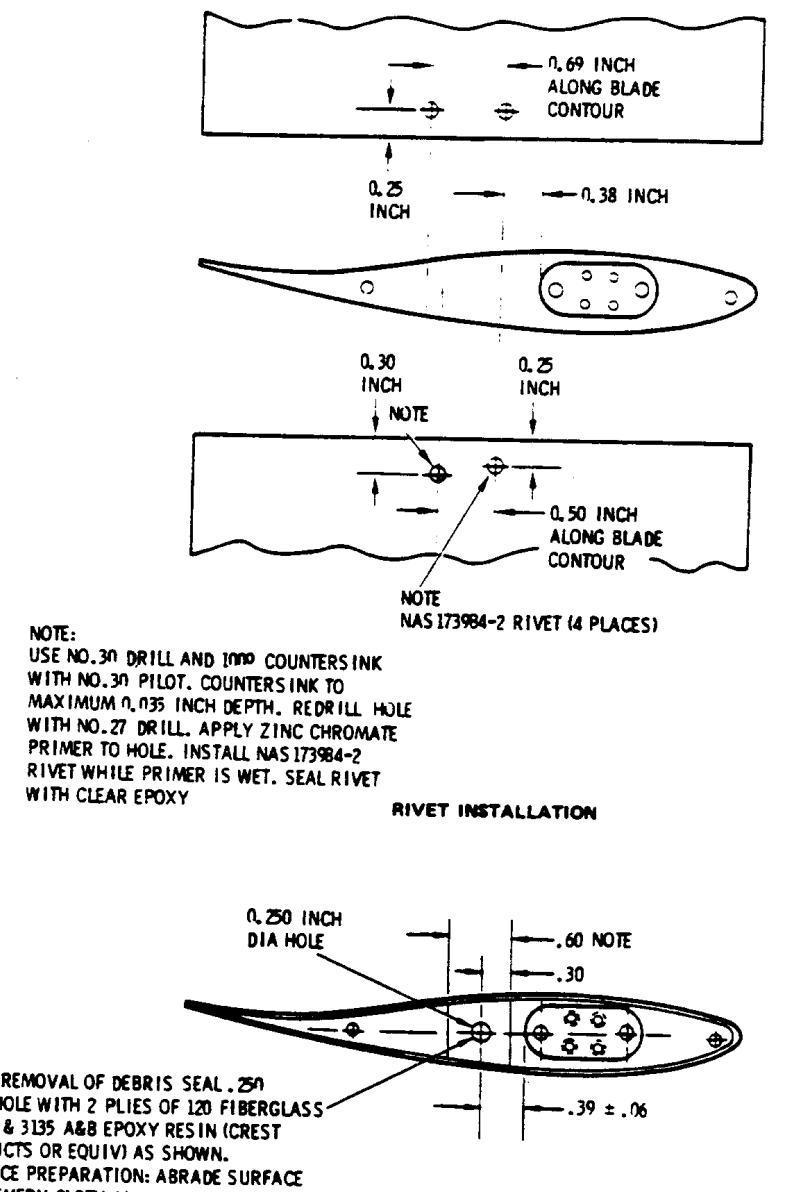
Figure 1. Riveting Tip-Cap to Blade; FOD Removal from Blade Interior

Part I of this Notice gives procedures for riveting tip-cap assemblies to the affected tail rotor blades. Debonding of the tip-cap from the blade could occur, causing loss of the tip-cap during operation of the helicopter.

c. With blade on a clean hard surface, measure and mark locations for rivet holes as shown in Figure 1.

d. Using No. 30 drill, carefully drill holes at locations marked on outboard and inboard surfaces of blade.

e. Using $100 \pm 1^{\circ}$ countersink with No. 30 pilot, countersink holes to 0.035 inch maximum depth; carefully open holes to 0.144 inch diameter using No. 27 drill.

f. Apply zinc chromate primer to holes and install NAS1739B4-2 rivets while primer is wet.

a. Drill 0.250 inch diameter hole through tip-cap as shown in Figure 1. Tip-cap is 0.070 inch thick at the point to be drilled.

d. Bond two plies of 120 fiberglass cloth over hole with 3135A and B epoxy resin, or equivalent. Allow epoxy to cure according to manufacturers instructions.

AFTER REMOVAL OF DEBRIS SEAL . 250 DIA. HOLE WITH 2 PLIES OF 120 FIBERGLASS CLOTH & 3135 A&B EPOXY RESIN (CREST PRODUCTS OR EQUIVI AS SHOWN. SURFACE PREPARATION: ABRADE SURFACE WITH EMERY CLOTH AND WIPE WITH 1, 1, 1-TRICHLOROETHANE SOLVENT. DO NOT ALLOW RES IN TO BUILD UP IN .250 DIA HOLE.

NOTE: FIBERGLASS THIS AREA. DO NOT PLACE FIBERGLASS CLOTH OVER OPENING FOR BALANCE WEIGHTS.
